# Access Compliance Report Public Rights-of-Way (Curb Ramps)

Main Street: KERTH\_DR Cross Street: BASKERVILLE\_RD Location: NE

ADA ID: RPRK211215123517 Ramp Type: Type 1 - Perpendicular Diagonal Initial Pass/Fail: Pass Overall Compliance: No Severity Score: 15

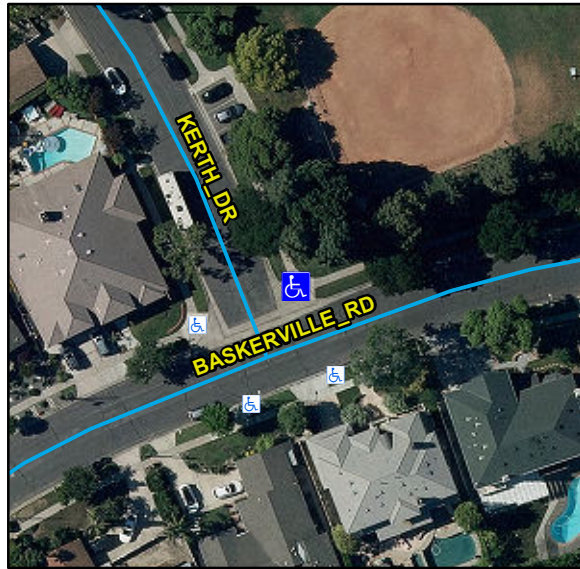
| Compliance | Description | Data | Compliance | Description | Data |
|---|---|---|---|---|---|
| No | Landing Run Slope (%) | 6.8 | N/A | Flare Traversable RT | No |
| Yes | Landing Cross Slope (%) | 0.8 | No | DWS Provided | No |
| Yes | Gutter Ponding | No | No | Curb Slope | 9.5 |

Remove & Replace Curb Ramp With Two New Directional Ramps or Equivalent.
