# Access Compliance Report Public Rights-of-Way (Curb Ramps)

Main Street: PEMBERTON\_RD Cross Street: BASKERVILLE\_RD Location: SW

ADA ID: RPRK211215124049 Ramp Type: Type 1 - Perpendicular Diagonal Initial Pass/Fail: Fail Overall Compliance: No Severity Score: 16

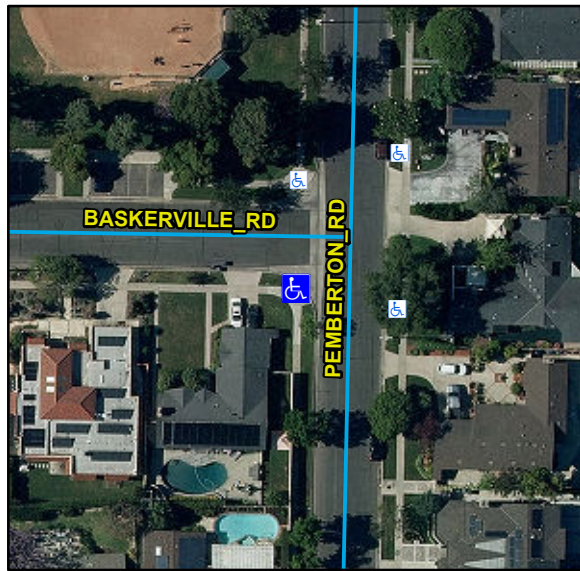
| Compliance | Description | Data | Compliance | Description | Data |
|---|---|---|---|---|---|
| No | Ramp Run Slope (%) | 9.3 | N/A | Flare Slope LT (%) | N/A |

Remove & Replace Curb Ramp With Two New Directional Ramps or Equivalent.

R304.2.2, R204.3, STD 1115
