# Access Compliance Report Public Rights-of-Way (Curb Ramps)

Main Street: BASKERVILLE\_RD Cross Street: PEMBERTON\_RD Location: NW

ADA ID: RPRK211215124231 Ramp Type: Type 1 - Perpendicular Diagonal Initial Pass/Fail: Pass Overall Compliance: No Severity Score: 16

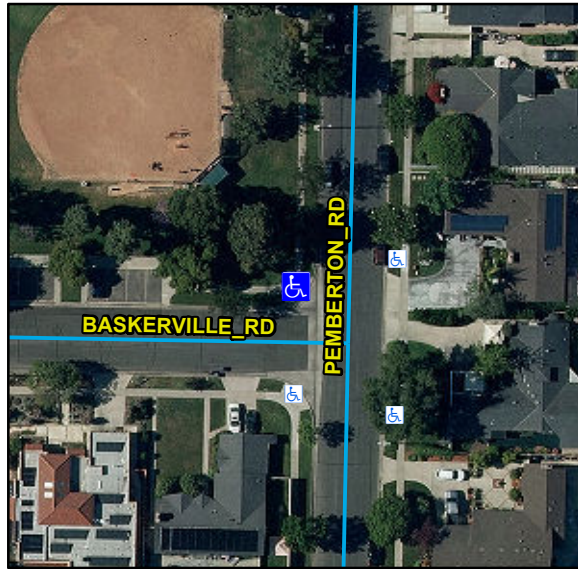
| Compliance | Description | Data | Compliance | Description | Data |
|---|---|---|---|---|---|
| No | Landing Run Slope (%) | 5.7 | N/A | Flare Traversable RT | No |
| Yes | Landing Cross Slope (%) | 0.5 | No | DWS Provided | No |

Remove & Replace Curb Ramp With Two New Directional Ramps or Equivalent.
