# Access Compliance Report Public Rights-of-Way (Curb Ramps)

Main Street: MONTECITO\_RD Cross Street: SHAKESPEARE\_DR Location: NW

ADA ID: RPRK211215130543 Ramp Type: Type 1 - Perpendicular Diagonal Initial Pass/Fail: Fail Overall Compliance: No Severity Score: 15

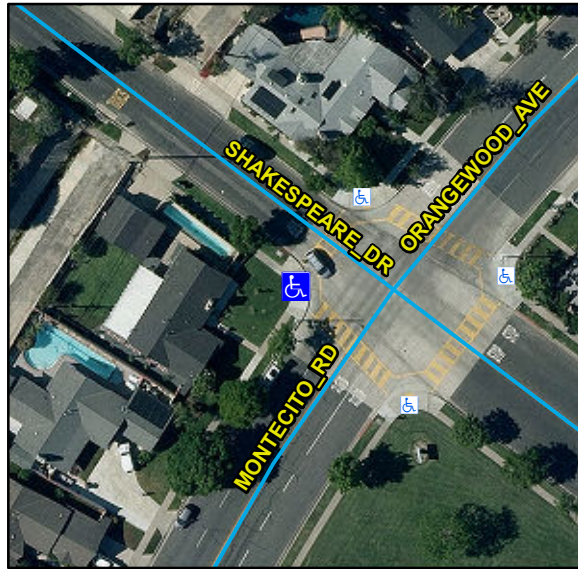
| Compliance | Description | Data | Compliance | Description | Data |
|---|---|---|---|---|---|
| No | Ramp Run Slope (%) | 9.7 | N/A | Flare Slope LT (%) | N/A |

Remove & Replace Curb Ramp With Two New Directional Ramps or Equivalent.

R304.2.2, STD 1115
