# Access Compliance Report Public Rights-of-Way (Curb Ramps)

| Main Street: ORANGEWOOD_AVE | | Cross Street: SHAKESPEARE_DR | | Location: | SE |
| ADA ID: RPRK211215131129 | Ramp Type: Type 4 - Parallel | Initial Pass/Fail: Fail | Overall Compliance: No | Severity Score: | 15 |

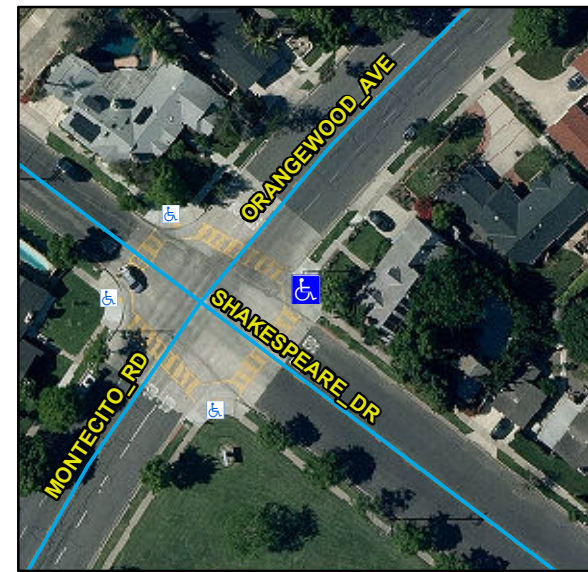
| Compliance | Description | Data | Compliance | Description | Data |
|---|---|---|---|---|---|
| No | Ramp Cross Slope LT (%) | 5.9 | No | Ramp Cross Slope RT (%) | 4.4 |

**Remove & Replace Curb Ramp With Two New Directional Ramps or Equivalent.**

**R304.5.3, STD 1115**

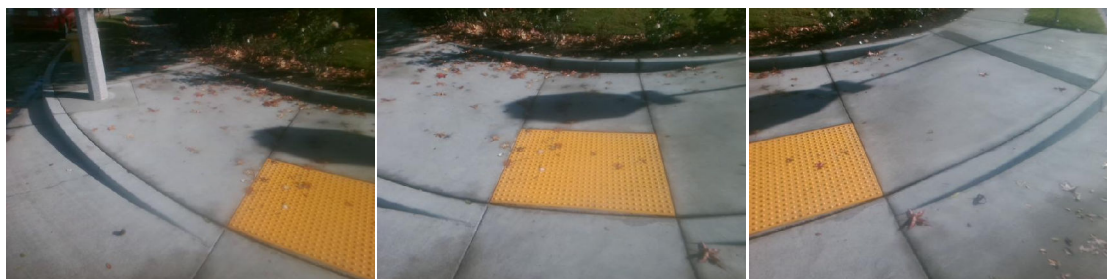
| Compliance | Description | Data | Compliance | Description | Data |
|---|---|---|---|---|---|
| N/A | Ramp Length LT (in) | 117 | N/A | Ramp Length RT (in) | 94 |
| Yes | Ramp Width LT (in) | 101 | Yes | Ramp Width RT (in) | 102 |
| Yes | Ramp Run Slope LT (%) | 6.6 | Yes | Ramp Run Slope RT (%) | 5.1 |
