# Access Compliance Report Public Rights-of-Way (Curb Ramps)

Main Street: BOSTONIAN\_DR Cross Street: BOSTONIAN\_DR Location: SW

ADA ID: RPRK211215132927 Ramp Type: Type 1 - Perpendicular Initial Pass/Fail: Fail Overall Compliance: No Severity Score: 16

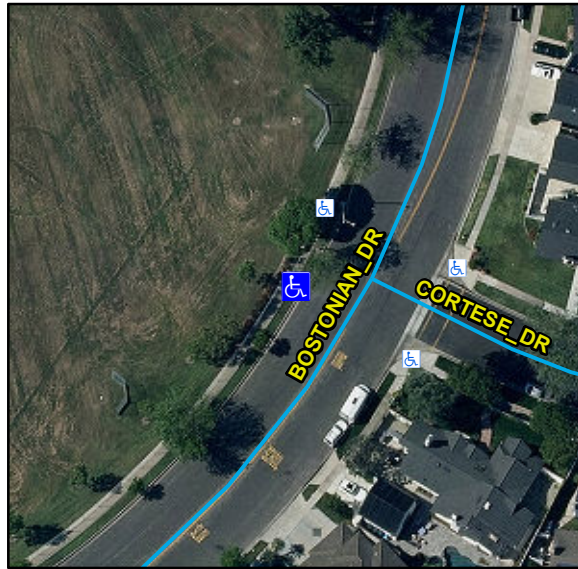
| Compliance | Description | Data | Compliance | Description | Data |
|---|---|---|---|---|---|
| No | Ramp Run Slope (%) | 8.4 | N/A | Flare Slope LT (%) | N/A |

Remove & Replace Entire Ramp.
