# Access Compliance Report Public Rights-of-Way (Curb Ramps)

| Main Street: MONTECITO_RD | | Cross Street: BOSTONIAN_DR | | Location: | NE |

| ADA ID: RPRK211215133137 | Ramp Type: Type 4 - Parallel | Initial Pass/Fail: Fail | Overall Compliance: No | Severity Score: | 2 |

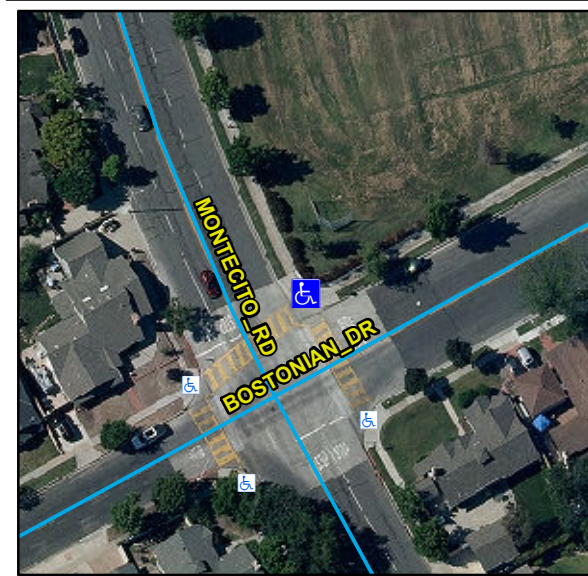
| Compliance | Description | Data | Compliance | Description | Data |
|---|---|---|---|---|---|
| Yes | Ramp Cross Slope LT (%) | 1.9 | No | Ramp Cross Slope RT (%) | 3.5 |

Possible Solutions:

**Remove & Replace Curb Ramp With Two New Directional Ramps or Equivalent.**

**R304.5.3, STD 1115**
