# Access Compliance Report Public Rights-of-Way (Curb Ramps)

Main Street: BOSTONIAN\_DR Cross Street: MONTECITO\_RD Location: NW

ADA ID: RPRK211215133621 Ramp Type: Type 4 - Parallel Initial Pass/Fail: Fail Overall Compliance: No Severity Score: 2

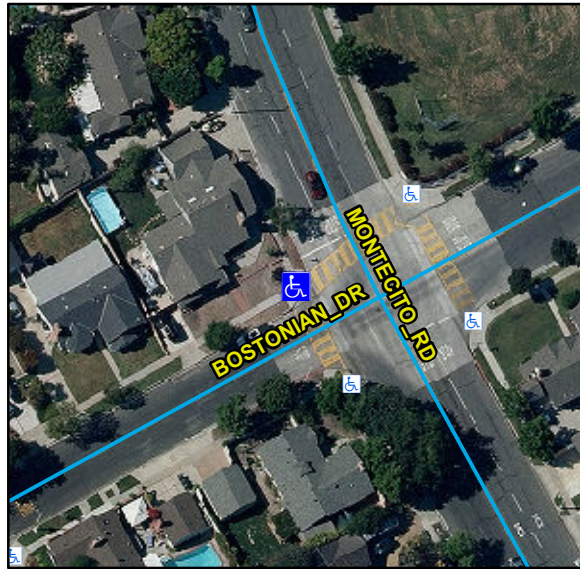
| Compliance | Description | Data | Compliance | Description | Data |
|---|---|---|---|---|---|
| Yes | Ramp Cross Slope LT (%) | 0.8 | No | Ramp Cross Slope RT (%) | 2.4 |

Remove & Replace Curb Ramp With Two New Directional Ramps or Equivalent.

R304.5.3, STD 1115
