# Access Compliance Report Public Rights-of-Way (Curb Ramps)

Main Street: MONTECITO\_RD Cross Street: BOSTONIAN\_DR Location: SW

ADA ID: RPRK211215133911 Ramp Type: Type 4 - Parallel Initial Pass/Fail: Fail Overall Compliance: No Severity Score: 30

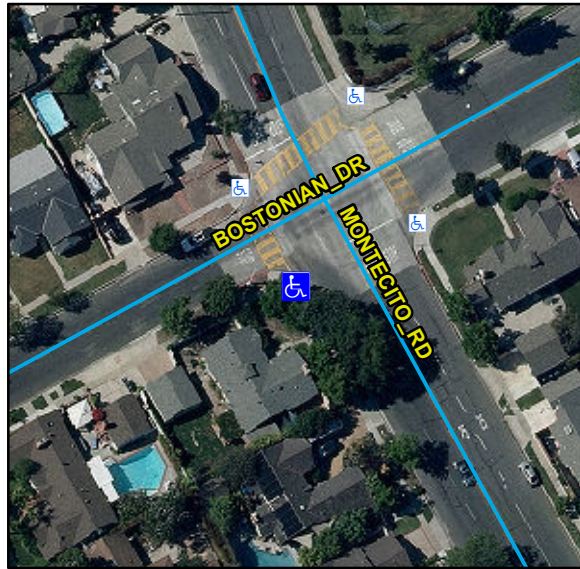
| Compliance | Description | Data | Compliance | Description | Data |
|---|---|---|---|---|---|
| No | Ramp Cross Slope LT (%) | 7.7 | No | Ramp Cross Slope RT (%) | 6.9 |

**Remove & Replace Curb Ramp With Two New Directional Ramps or Equivalent.**

**R304.5.3, STD 1115**
