# Access Compliance Report Public Rights-of-Way (Curb Ramps)

Main Street: BOSTONIAN\_DR Cross Street: MONTECITO\_RD Location: SE

ADA ID: RPRK211215134208 Ramp Type: Type 4 - Parallel Initial Pass/Fail: Fail Overall Compliance: No Severity Score: 2

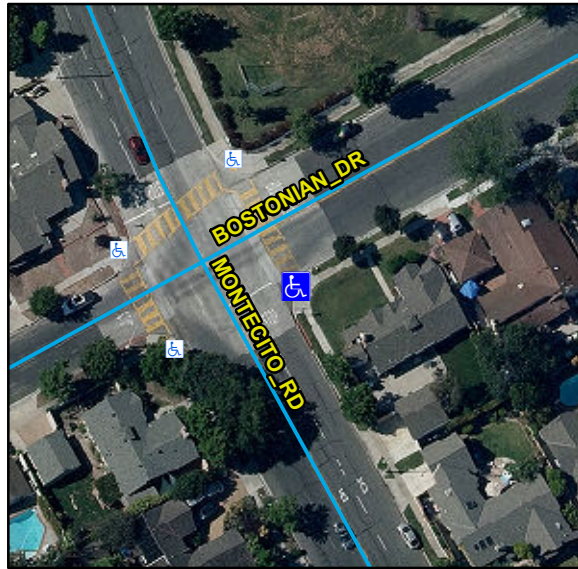
| Compliance | Description | Data | Compliance | Description | Data |
|---|---|---|---|---|---|
| No | Ramp Cross Slope LT (%) | 4.6 | No | Ramp Cross Slope RT (%) | 4.3 |

**Remove & Replace Curb Ramp With Two New Directional Ramps or Equivalent.**

**R304.5.3, STD 1115**
