# Access Compliance Report Public Rights-of-Way (Curb Ramps)

Main Street: CORTESE\_DR Cross Street: BOSTONIAN\_DR Location: SE

ADA ID: RPRK211215134500 Ramp Type: Type 4 - Parallel Initial Pass/Fail: Fail Overall Compliance: No Severity Score: 16

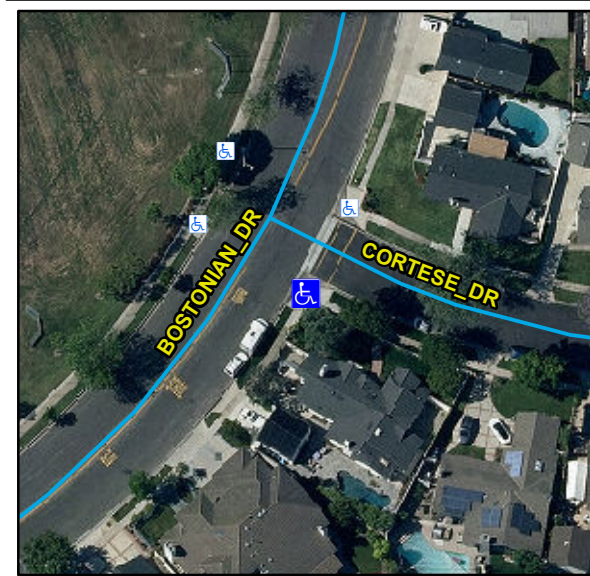
| Compliance | Description | Data | Compliance | Description | Data |
|---|---|---|---|---|---|
| No | Ramp Run Slope LT (%) | 9 | Yes | Ramp Run Slope RT (%) | 6.4 |

Possible Solutions:  
**Remove & Replace Curb Ramp With Two New Directional Ramps or Equivalent. Restripe Crosswalk.**

OC Std/PROW:  
**R304.3.2, STD 1115**

Total Cost: \$ 8000
