# Access Compliance Report Public Rights-of-Way (Curb Ramps)

Main Street: BOSTONIAN\_DR Cross Street: CORTESE\_DR Location: NE

ADA ID: RPRK211215134924 Ramp Type: Type 4 - Parallel Initial Pass/Fail: Pass Overall Compliance: No Severity Score: 20

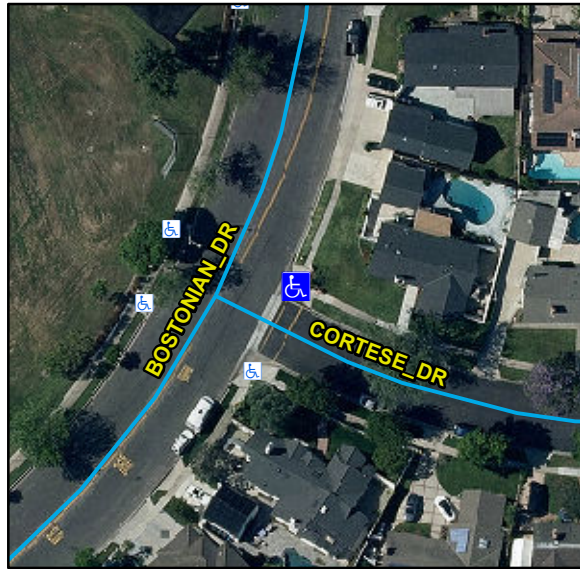
**Remove & Replace Curb Ramp With Two New Directional Ramps or Equivalent. Restripe Crosswalk. Gutter Ponding Observed.**

| Compliance | Description | Data | Compliance | Description | Data |
|---|---|---|---|---|---|
| N/A | Landing Present | No | No | DWS Provided | No |
| No | Landing Width (in) | N/A | N/A | DWS Length (in) | N/A |
| No | Landing Run Slope (%) | N/A | N/A | DWS Full Width | N/A |
| No | Landing Cross Slope (%) | N/A | | DWS Offset Type | N/A |
| No | Gutter Ponding | Yes | Yes | Curb Slope | 3.7 |

**R304.2.1, R304.2.2-Perp, R304.3.2-Para, R304.5.3, R305, R207.1, R302.7, STD 1115**
