# Access Compliance Report Public Rights-of-Way (Curb Ramps)

| Main Street: ROSSMOOR_WAY | | Cross Street: BOSTONIAN_DR | | Location: | S |
| ADA ID: RPRK211215135231 | Ramp Type: Type 4 - Parallel | Initial Pass/Fail: Fail | Overall Compliance: No | Severity Score: | 2 |

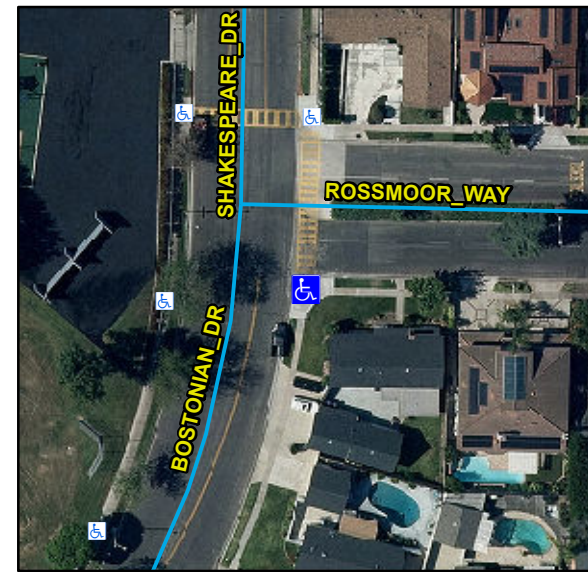
| Compliance | Description | Data | Compliance | Description | Data |
|---|---|---|---|---|---|
| No | Ramp Cross Slope LT (%) | 3.2 | Yes | Ramp Cross Slope RT (%) | 1.6 |

**Remove & Replace Curb Ramp With Two New Directional Ramps or Equivalent.**

**R304.5.3, STD 1115**

Total Cost: \$ 4000
