# Access Compliance Report Public Rights-of-Way (Curb Ramps)

Main Street: WIMBLETON\_DR Cross Street: SHAKESPEARE\_DR Location: SE

ADA ID: RPRK211215140504 Ramp Type: Type 1 - Perpendicular Diagonal Initial Pass/Fail: Pass Overall Compliance: No Severity Score: 14

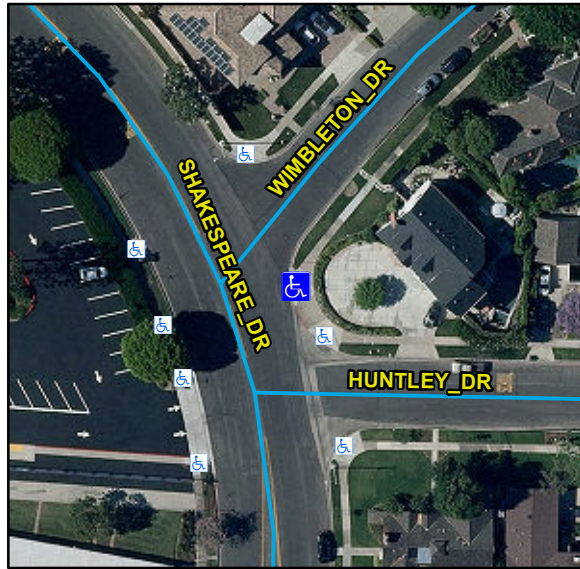
Remove & Replace Curb Ramp With Two New Directional Ramps or Equivalent. Gutter Ponding Observed.

| Compliance | Description | Data | Compliance | Description | Data |
|---|---|---|---|---|---|
| Yes | Landing Cross Slope (%) | 0.2 | No | DWS Provided | No |
| No | Gutter Ponding | Yes | Yes | Curb Slope | 1.3 |
