# Access Compliance Report Public Rights-of-Way (Curb Ramps)

Main Street: SHAKESPEARE\_DR Cross Street: WIMBLETON\_DR Location: NE

ADA ID: RPRK211215140846 Ramp Type: Type 1 - Perpendicular Diagonal Initial Pass/Fail: Fail Overall Compliance: No Severity Score: 16

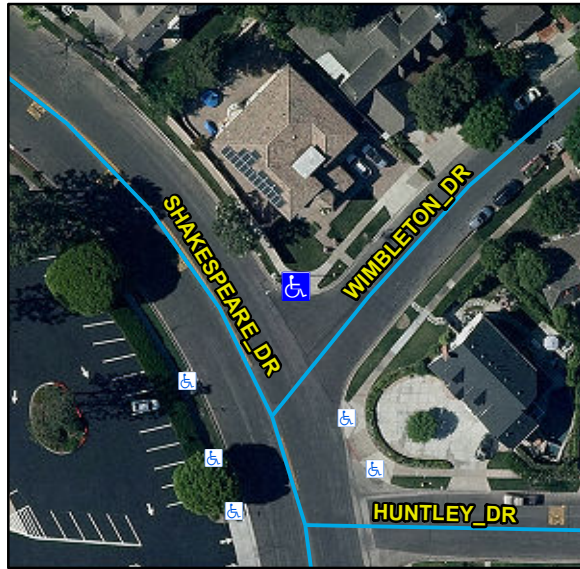
| Compliance | Description | Data | Compliance | Description | Data |
|---|---|---|---|---|---|
| No | Ramp Run Slope (%) | 9.6 | N/A | Flare Slope LT (%) | N/A |

Remove & Replace Curb Ramp With Two New Directional Ramps or Equivalent.
