# Access Compliance Report

## Public Rights-of-Way

### (Curb Ramps)

Main Street: KENILWORTH\_DR Cross Street: SHAKESPEARE\_DR Location: E

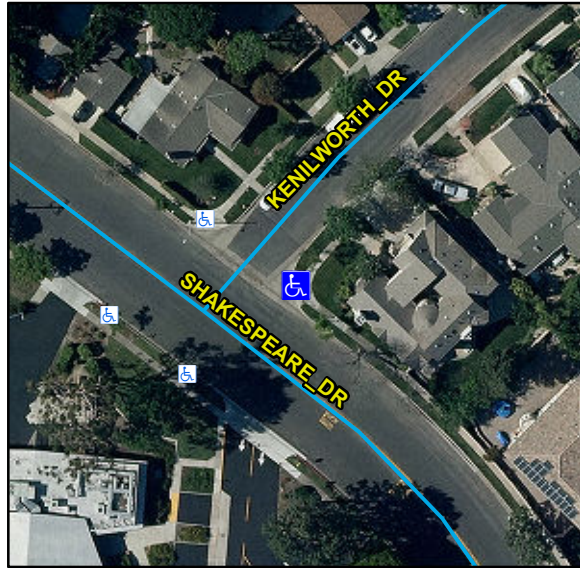
ADA ID: RPRK211215141114 Ramp Type: Type 1 - Perpendicular Diagonal Initial Pass/Fail: Pass Overall Compliance: No Severity Score: 14

| Compliance | Description | Data | Compliance | Description | Data |
|---|---|---|---|---|---|
| Yes | Landing Cross Slope (%) | 1.1 | No | DWS Provided | No |

**Remove & Replace Curb Ramp With Two New Directional Ramps or Equivalent.**

**R204.3, R304.2.1, R305, STD 1115**
