# Access Compliance Report Public Rights-of-Way (Curb Ramps)

Main Street: SHAKESPEARE\_DR Cross Street: KENILWORTH\_DR Location: N

ADA ID: RPRK211215141454 Ramp Type: Type 1 - Perpendicular Diagonal Initial Pass/Fail: Pass Overall Compliance: No Severity Score: 10

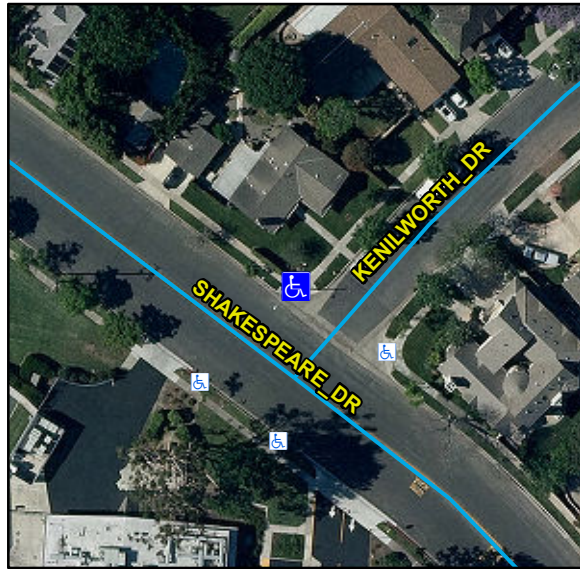
| Compliance | Description | Data | Compliance | Description | Data |
|---|---|---|---|---|---|
| No | Landing Run Slope (%) | 3.3 | N/A | Flare Traversable RT | No |
| Yes | Landing Cross Slope (%) | 0.9 | No | DWS Provided | No |

Remove & Replace Curb Ramp With Two New Directional Ramps or Equivalent.
