# Access Compliance Report Public Rights-of-Way (Curb Ramps)

| Main Street: WALLINGSFORD_RD | | Cross Street: HUNTLEY_DR | | Location: | NE |
| ADA ID: RPRK211215142055 | Ramp Type:Type 1 - Perpendicular Diagonal Initial Pass/Fail: Fail | | Overall Compliance: No | Severity Score: | 16 |

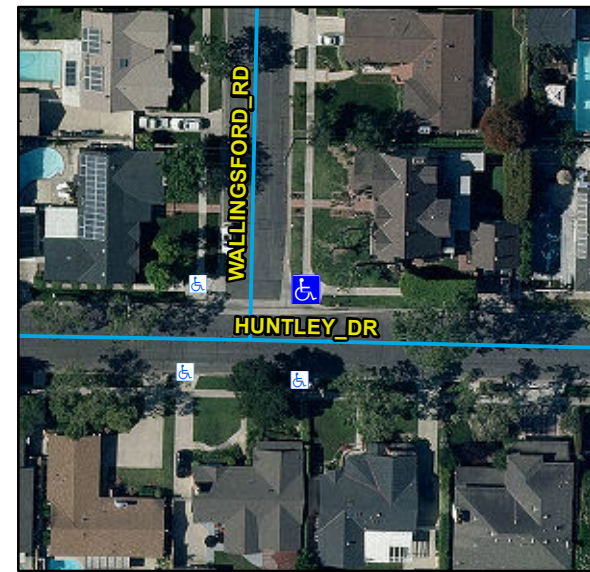
| Compliance | Description | Data | Compliance | Description | Data |
|---|---|---|---|---|---|
| No | Ramp Run Slope (%) | 8.4 | N/A | Flare Slope LT (%) | N/A |
| No | Ramp Cross Slope (%) | 2.7 | N/A | Flare Traversable LT | N/A |

**Remove & Replace Curb Ramp With Two New Directional Ramps or Equivalent.**

**R204.3, R304.2.2, R304.5.3, STD 1115**

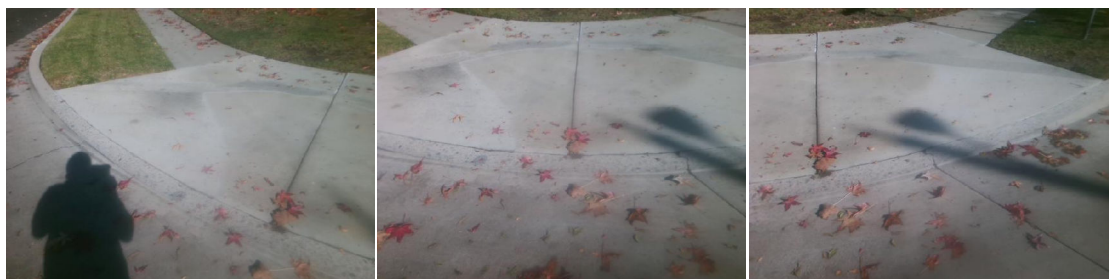
| Compliance | Description | Data | Compliance | Description | Data |
|---|---|---|---|---|---|
| N/A | Ramp Length (in) | 81 | N/A | Flare Type LT | |
| Yes | Ramp Width (in) | 48 | | | N/A |
