# Access Compliance Report Public Rights-of-Way (Curb Ramps)

Main Street: WALLINGSFORD\_RD Cross Street: ORANGEWOOD\_AVE Location: SW

ADA ID: RPRK211215143034 Ramp Type: Type 4 - Parallel Initial Pass/Fail: Fail Overall Compliance: No Severity Score: 15

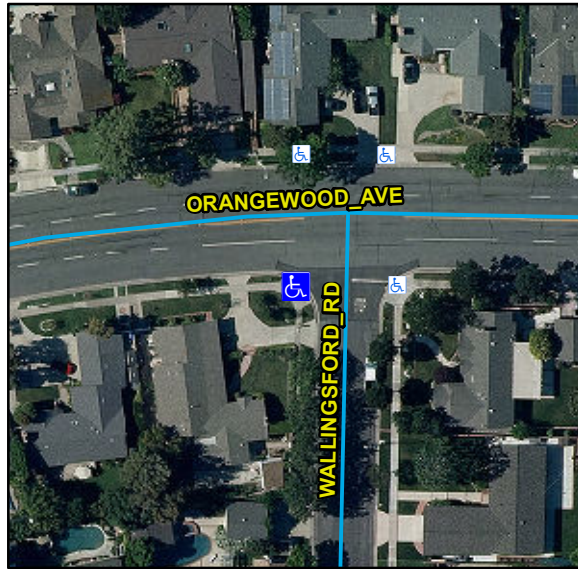
| Compliance | Description | Data | Compliance | Description | Data |
|---|---|---|---|---|---|
| No | Ramp Cross Slope LT (%) | 3.1 | No | Ramp Cross Slope RT (%) | 6.6 |

Remove & Replace Curb Ramp With Two New Directional Ramps or Equivalent.

R204.3, R304.5.3, STD 1115

Total Cost: \$ 4000
