# Access Compliance Report Public Rights-of-Way (Curb Ramps)

Main Street: KENILWORTH\_DR Cross Street: WALLINGSFORD\_RD Location: NW

ADA ID: RPRK211215143320 Ramp Type: Type 1 - Perpendicular Diagonal Initial Pass/Fail: Fail Overall Compliance: No Severity Score: 2

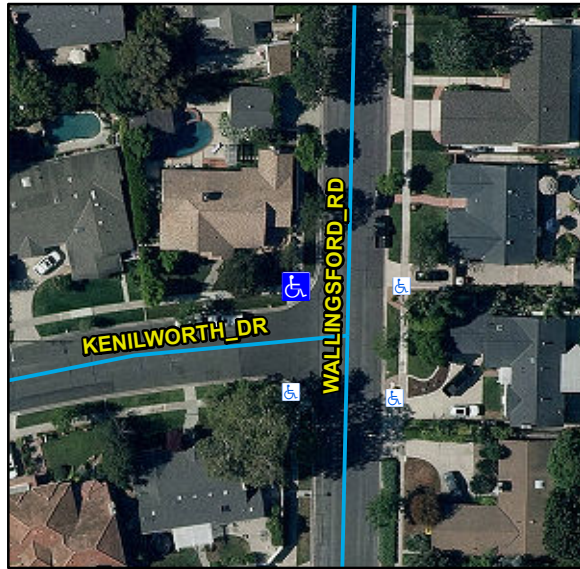
| Compliance | Description | Data | Compliance | Description | Data |
|---|---|---|---|---|---|
| No | Ramp Cross Slope (%) | 3.7 | N/A | Flare Traversable LT | N/A |

Remove & Replace Curb Ramp With Two New Directional Ramps or Equivalent.

R304.2.2, R204.3, R304.5.3, STD 1115
