# Access Compliance Report Public Rights-of-Way (Curb Ramps)

Main Street: WALLINGSFORD\_RD Cross Street: KENILWORTH\_DR Location: SW

ADA ID: RPRK211215143540 Ramp Type: Type 1 - Perpendicular Diagonal Initial Pass/Fail: Fail Overall Compliance: No Severity Score: 15

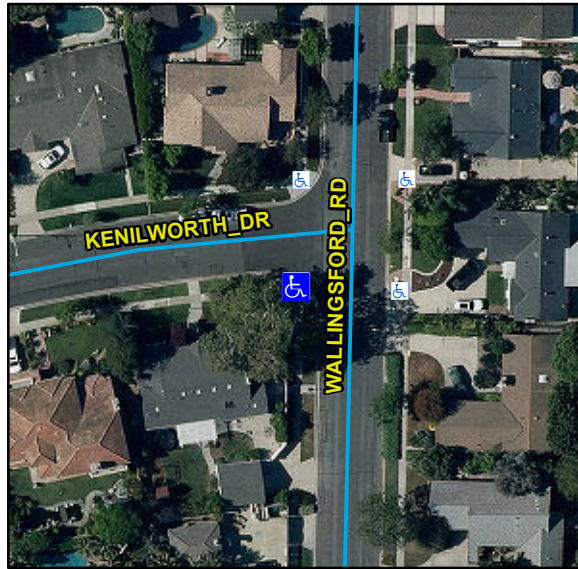
| Compliance | Description | Data | Compliance | Description | Data |
|---|---|---|---|---|---|
| No | Ramp Run Slope (%) | 9.3 | N/A | Flare Slope LT (%) | N/A |

Remove & Replace Curb Ramp With Two New Directional Ramps or Equivalent.

R204.3, R304.2.2, STD 1115
