# Access Compliance Report Public Rights-of-Way (Curb Ramps)

Main Street: WIMBLETON\_DR Cross Street: WALLINGSFORD\_RD Location: NW

ADA ID: RPRK211215143810 Ramp Type: Type 1 - Perpendicular Diagonal Initial Pass/Fail: Pass Overall Compliance: No Severity Score: 10

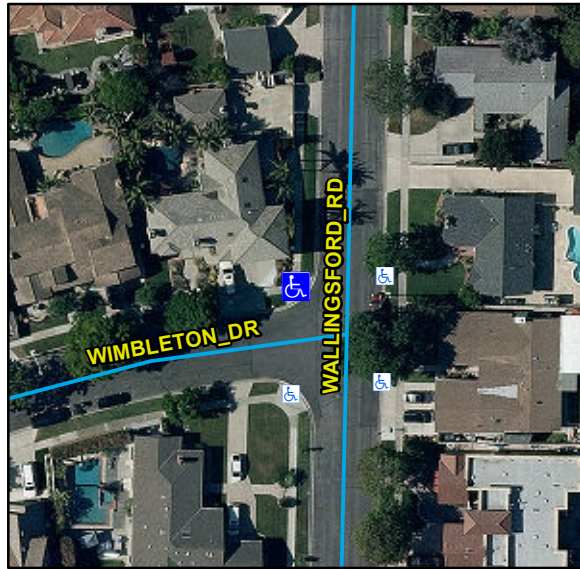
| Compliance | Description | Data | Compliance | Description | Data |
|---|---|---|---|---|---|
| Yes | Landing Cross Slope (%) | 1.4 | No | DWS Provided | No |
| No | Gutter Ponding | Yes | Yes | Curb Slope | 1.7 |

Remove & Replace Curb Ramp With Two New Directional Ramps or Equivalent. Gutter Ponding Observed.
