# Access Compliance Report Public Rights-of-Way (Curb Ramps)

Main Street: WALLINGSFORD\_RD Cross Street: WIMBLETON\_DR Location: SW

ADA ID: RPRK211215144119 Ramp Type: Type 1 - Perpendicular Diagonal Initial Pass/Fail: Fail Overall Compliance: No Severity Score: 16

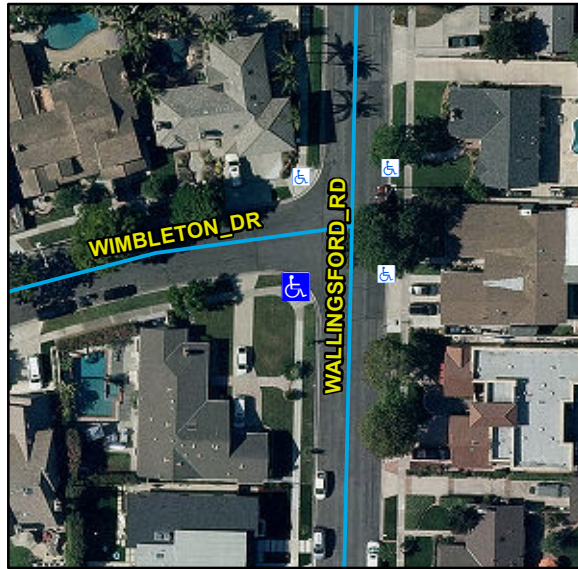
| Compliance | Description | Data | Compliance | Description | Data |
|---|---|---|---|---|---|
| No | Ramp Run Slope (%) | 8.6 | N/A | Flare Slope LT (%) | N/A |
| No | Ramp Cross Slope (%) | 2.1 | N/A | Flare Traversable LT | N/A |

Remove & Replace Curb Ramp With Two New Directional Ramps or Equivalent.

R204.3, R304.2.2, R304.5.3, STD 1115
