# Access Compliance Report Public Rights-of-Way (Curb Ramps)

Main Street: HUNTLEY\_DR Cross Street: WALLINGSFORD\_RD Location: NW

ADA ID: RPRK211215144316 Ramp Type: Type 1 - Perpendicular Diagonal Initial Pass/Fail: Pass Overall Compliance: No Severity Score: 16

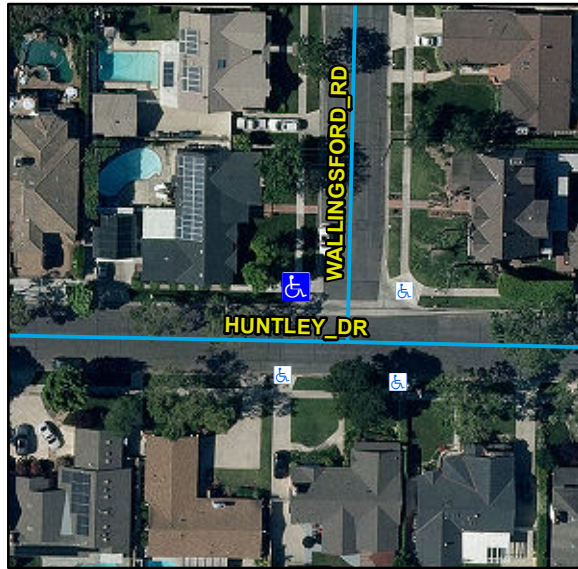
| Compliance | Description | Data | Compliance | Description | Data |
|---|---|---|---|---|---|
| Yes | Landing Cross Slope (%) | 1.6 | No | DWS Provided | No |
| Yes | Gutter Ponding | No | No | Curb Slope | 7.1 |
| No | Gutter Run Slope (%) | 5.3 | | Road Cross Slope (%) | 3.2 |

**Remove & Replace Curb Ramp With Two New Directional Ramps or Equivalent. Remove & Replace Gutter.**

**R304.2.2, R204.3, R305, R304.5.4, STD 1115**
