# Access Compliance Report Public Rights-of-Way (Curb Ramps)

Main Street: MARTHA\_ANN\_DR Cross Street: SALMON\_DR Location: NE

ADA ID: RPRK211216112537 Ramp Type: Type 1 - Perpendicular Diagonal Initial Pass/Fail: Pass Overall Compliance: No Severity Score: 22

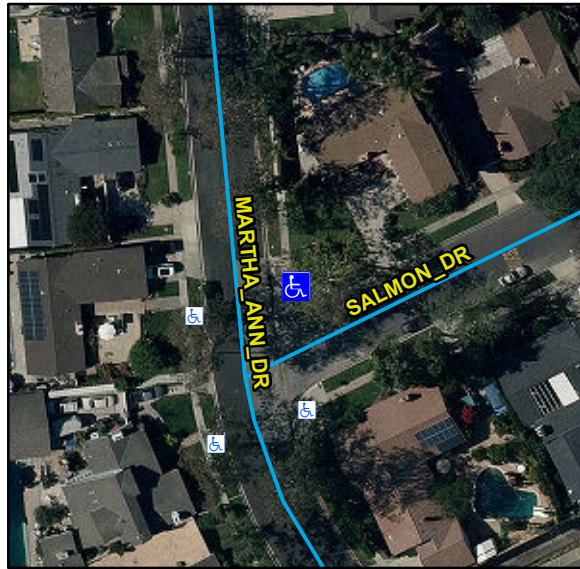
| Compliance | Description | Data | Compliance | Description | Data |
|---|---|---|---|---|---|
| No | Landing Width (in) | N/A | N/A | Flare Slope RT (%) | 6.8 |
| No | Landing Run Slope (%) | N/A | N/A | Flare Traversable RT | No |
| No | Landing Cross Slope (%) | N/A | No | DWS Provided | No |
| No | Gutter Lip Height (in) | 0.25 | | Road Run Slope (%) | 1.5 |

Remove & Replace Curb Ramp With Two New Directional Ramps or Equivalent. Grind Gutter Lip.
