# Access Compliance Report Public Rights-of-Way (Curb Ramps)

Main Street: SALMON\_DR Cross Street: KENSINGTON\_RD Location: NW

ADA ID: RPRK211216112942 Ramp Type: Type 1 - Perpendicular Diagonal Initial Pass/Fail: Pass Overall Compliance: No Severity Score: 12

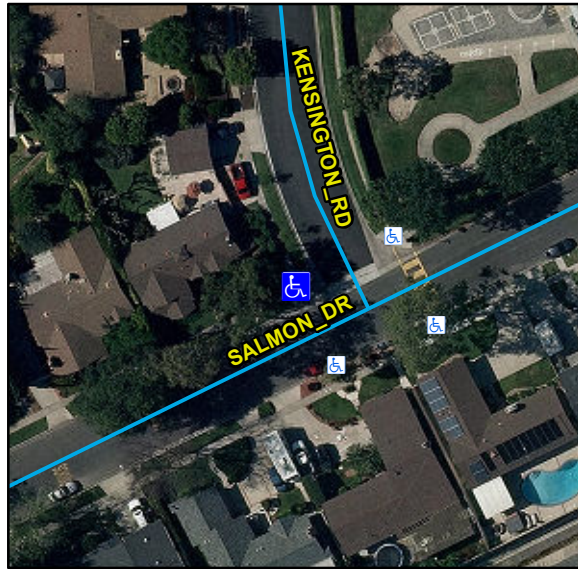
| Compliance | Description | Data | Compliance | Description | Data |
|---|---|---|---|---|---|
| Yes | Landing Cross Slope (%) | 1.9 | No | DWS Provided | No |
| Yes | Gutter Ponding | No | No | Curb Slope | 5.4 |

Remove & Replace Curb Ramp With Two New Directional Ramps or Equivalent.

R304.2.2, R204.3, R305, STD 1115
