# Access Compliance Report Public Rights-of-Way (Curb Ramps)

| Main Street: KENSINGTON_RD | | Cross Street: SALMON_DR | | Location: | NE |
| ADA ID: RPRK211216113316 | Ramp Type:Type 1 - Perpendicular Diagonal Initial Pass/Fail: Pass | | Overall Compliance: No | Severity Score: | 10 |

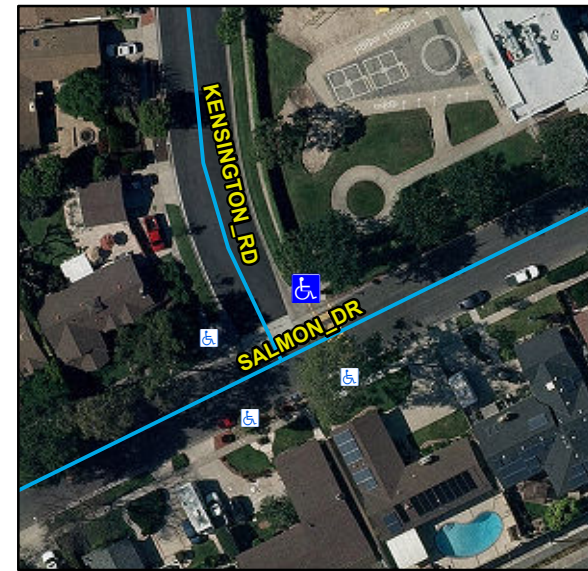
| Compliance | Description | Data | Compliance | Description | Data |
|---|---|---|---|---|---|
| Yes | Obstructions Present? | No | N/A | Utilities Present? | Yes |
| | Obstruction Dimensions | <Null> | | Mail Box | |

| Compliance | Description | Data | Compliance | Description | Data |
|---|---|---|---|---|---|
| Yes | Landing Cross Slope (%) | 0.8 | No | DWS Provided | No |
| Yes | Gutter Ponding | No | No | Curb Slope | 5.2 |

Remove & Replace Curb Ramp With Two New Directional Ramps or Equivalent. Utility Present.

R304.2.2, R204.3, R305, STD 1115

Total Cost: \$ 6160

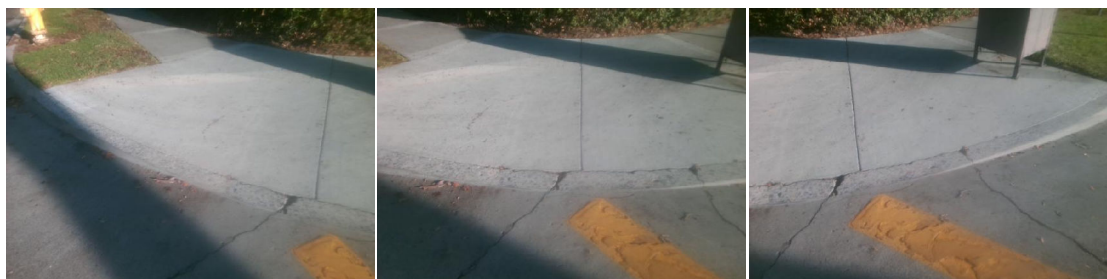
| Compliance | Description | Data | Compliance | Description | Data |
|---|---|---|---|---|---|
| | Obstruction Types | N/A | | Utility Types | |
