# Access Compliance Report Public Rights-of-Way (Curb Ramps)

Main Street: GERTRUDE\_DR Cross Street: ARGYLE\_DR Location: SE

ADA ID: RPRK211216114322 Ramp Type: Type 1 - Perpendicular Diagonal Initial Pass/Fail: Pass Overall Compliance: No Severity Score: 10

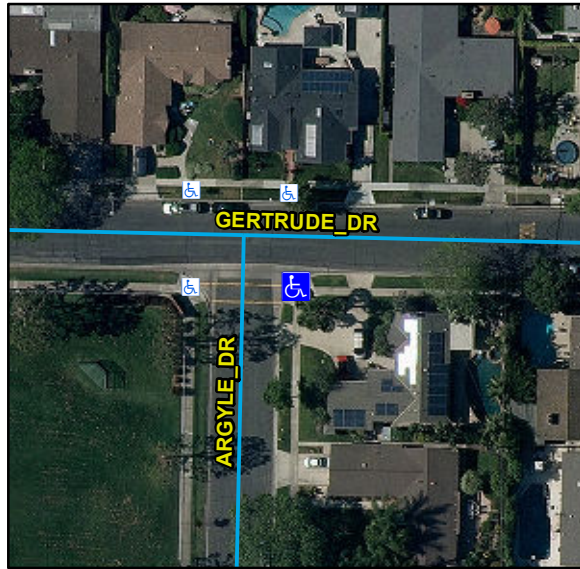
**Remove & Replace Curb Ramp With Two New Directional Ramps or Equivalent. Gutter Ponding Observed.**

| Compliance | Description | Data | Compliance | Description | Data |
|---|---|---|---|---|---|
| No | Landing Run Slope (%) | 4 | N/A | Flare Traversable RT | No |
| Yes | Landing Cross Slope (%) | 0.4 | No | DWS Provided | No |
| No | Gutter Ponding | Yes | Yes | Curb Slope | 1.3 |
