# Access Compliance Report Public Rights-of-Way (Curb Ramps)

Main Street: ARGYLE\_DR Cross Street: GERTRUDE\_DR Location: SW

ADA ID: RPRK211216114602 Ramp Type: Type 1 - Perpendicular Diagonal Initial Pass/Fail: Pass Overall Compliance: No Severity Score: 14

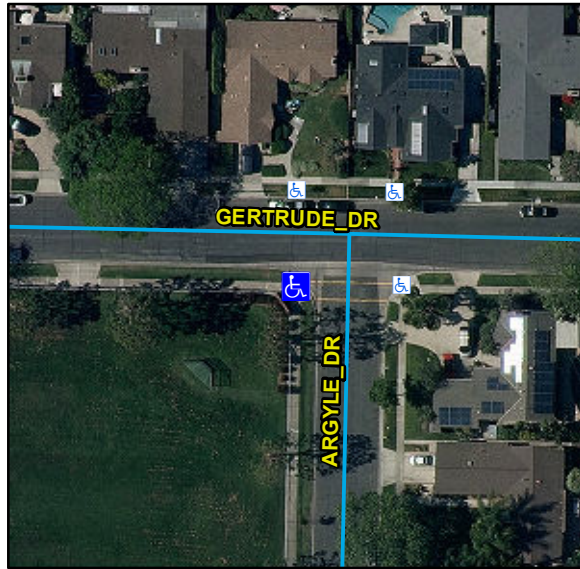
| Compliance | Description | Data | Compliance | Description | Data |
|---|---|---|---|---|---|
| No | Landing Run Slope (%) | 2.4 | N/A | Flare Traversable RT | Yes |
| Yes | Landing Cross Slope (%) | 1.2 | No | DWS Provided | No |
| Yes | Gutter Ponding | No | No | Curb Slope | 9.6 |

**Remove & Replace Curb Ramp With Two New Directional Ramps or Equivalent.**
