# Access Compliance Report Public Rights-of-Way (Curb Ramps)

Main Street: WEMBLEY\_RD Cross Street: GERTRUDE\_DR Location: NE

ADA ID: RPRK211216115037 Ramp Type: Type 1 - Perpendicular Diagonal Initial Pass/Fail: Pass Overall Compliance: No Severity Score: 16

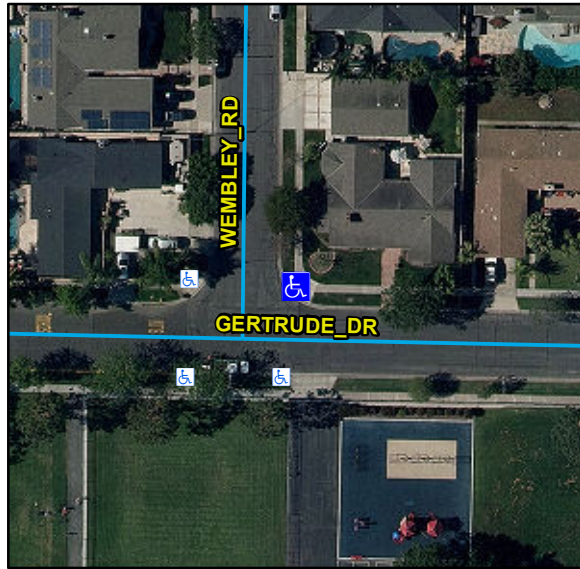
| Compliance | Description | Data | Compliance | Description | Data |
|---|---|---|---|---|---|
| Yes | Landing Cross Slope (%) | 1.2 | No | DWS Provided | No |
| Yes | Gutter Ponding | No | No | Curb Slope | 6.7 |

**Remove & Replace Curb Ramp With Two New Directional Ramps or Equivalent.**

**R304.2.2, R204.3, R304.2.1, R305, STD 1115**
