# Access Compliance Report Public Rights-of-Way (Curb Ramps)

Main Street: GERTRUDE\_DR Cross Street: WEMBLEY\_RD Location: NW

ADA ID: RPRK211216115423 Ramp Type: Type 1 - Perpendicular Diagonal Initial Pass/Fail: Fail Overall Compliance: No Severity Score: 16

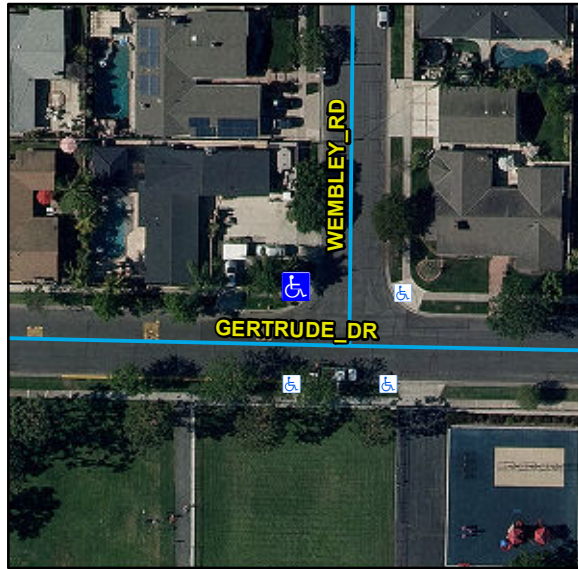
| Compliance | Description | Data | Compliance | Description | Data |
|---|---|---|---|---|---|
| No | Ramp Run Slope (%) | 9.3 | N/A | Flare Slope LT (%) | N/A |

Remove & Replace Curb Ramp With Two New Directional Ramps or Equivalent.

R304.2.2, R204.3, STD 1115
