# Access Compliance Report Public Rights-of-Way (Curb Ramps)

Main Street: ENGEL\_DR Cross Street: WEMBLEY\_RD Location: SE

ADA ID: RPRK211216115718 Ramp Type: Type 1 - Perpendicular Diagonal Initial Pass/Fail: Pass Overall Compliance: No Severity Score: 16

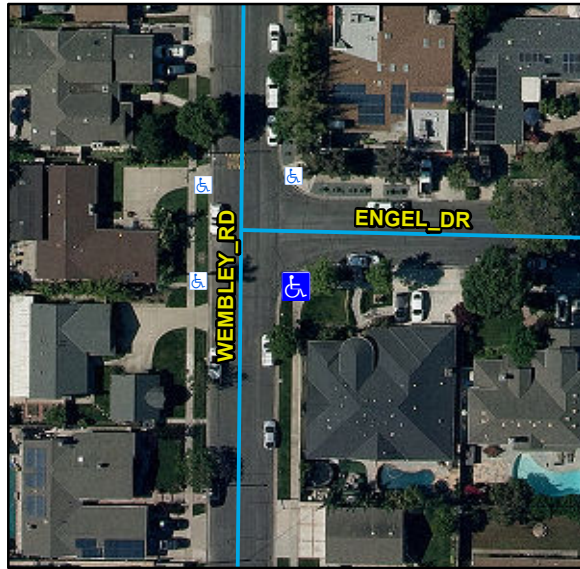
| Compliance | Description | Data | Compliance | Description | Data |
|---|---|---|---|---|---|
| No | Landing Run Slope (%) | 3.1 | N/A | Flare Traversable RT | No |
| Yes | Landing Cross Slope (%) | 1.5 | No | DWS Provided | No |
| No | Gutter Ponding | Yes | No | Curb Slope | 8.5 |
| No | Gutter Run Slope (%) | 5.9 | | Road Cross Slope (%) | 9.2 |

Remove & Replace Curb Ramp With Two New Directional Ramps or Equivalent. Remove & Replace Gutter.
