# Access Compliance Report Public Rights-of-Way (Curb Ramps)

Main Street: WEMBLEY\_RD Cross Street: ENGEL\_DR Location: NE

ADA ID: RPRK211216120135 Ramp Type: Type 1 - Perpendicular Diagonal Initial Pass/Fail: Pass Overall Compliance: No Severity Score: 10

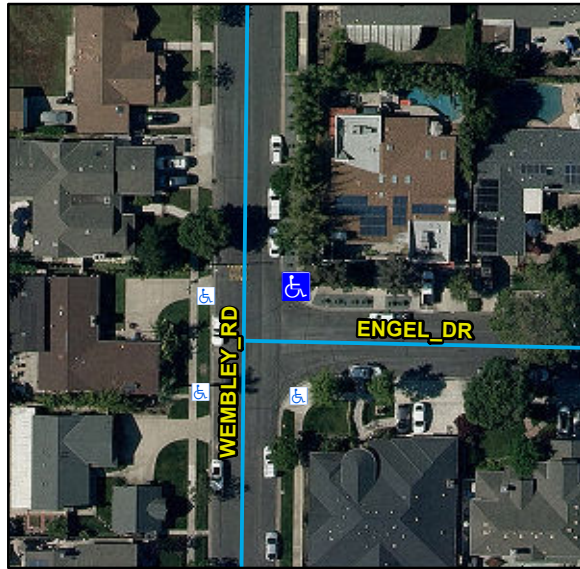
| Compliance | Description | Data | Compliance | Description | Data |
|---|---|---|---|---|---|
| No | Landing Run Slope (%) | 2.1 | N/A | Flare Traversable RT | No |
| Yes | Landing Cross Slope (%) | 0.7 | No | DWS Provided | No |
| No | Gutter Ponding | Yes | No | Curb Slope | 6.3 |

Remove & Replace Curb Ramp With Two New Directional Ramps or Equivalent.
