# Access Compliance Report Public Rights-of-Way (Curb Ramps)

Main Street: CHIANTI\_DR Cross Street: BLUME\_DR Location: NE

ADA ID: RPRK211216121205 Ramp Type: Type 1 - Perpendicular Diagonal Initial Pass/Fail: Pass Overall Compliance: No Severity Score: 0

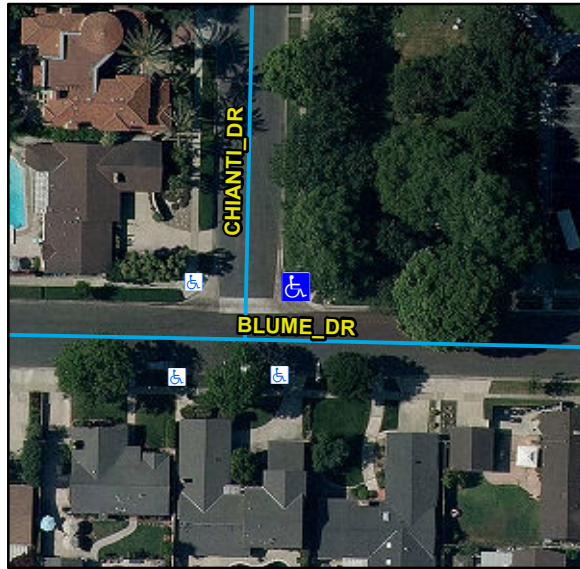
R304.2.1, STD 1115

| Compliance | Description | Data | Compliance | Description | Data |
|---|---|---|---|---|---|
| N/A | Landing Movement Obstructed? | Yes | Yes | DWS Contrast | Yes |

Remove & Replace Landing.
