# Access Compliance Report Public Rights-of-Way (Curb Ramps)

Main Street: BLUME\_DR Cross Street: CHIANTI\_DR Location: NW

ADA ID: RPRK211216121720 Ramp Type: Type 1 - Perpendicular Diagonal Initial Pass/Fail: Fail Overall Compliance: No Severity Score: 15

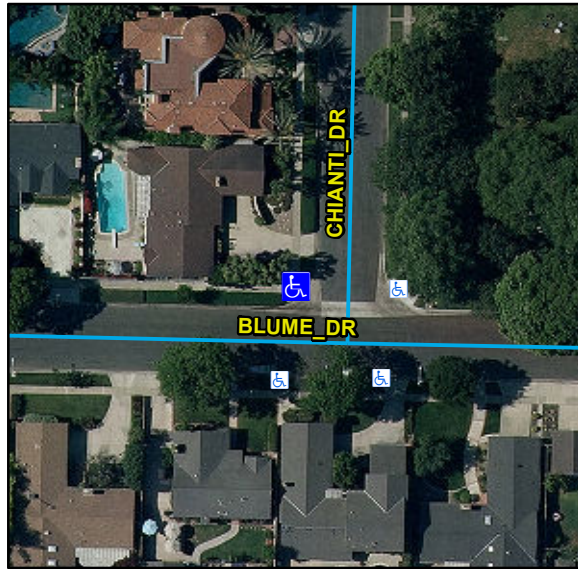
| Compliance | Description | Data | Compliance | Description | Data |
|---|---|---|---|---|---|
| No | Ramp Run Slope (%) | 8.8 | N/A | Flare Slope LT (%) | N/A |

**Remove & Replace Curb Ramp With Two New Directional Ramps or Equivalent.**

**R204.3, R304.2.2, STD 1115**
