# Access Compliance Report Public Rights-of-Way (Curb Ramps)

Main Street: CHRISTY\_LN Cross Street: BLUME\_DR Location: SW

ADA ID: RPRK211216122429 Ramp Type: Type 1 - Perpendicular Diagonal Initial Pass/Fail: Pass Overall Compliance: No Severity Score: 15

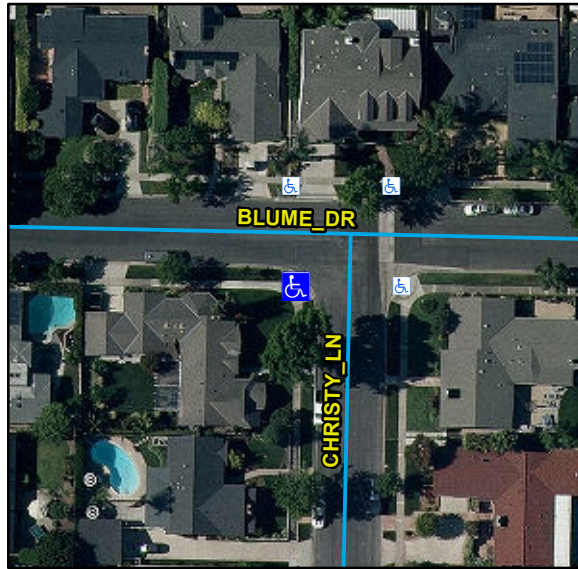
| Compliance | Description | Data | Compliance | Description | Data |
|---|---|---|---|---|---|
| Yes | Landing Cross Slope (%) | 0.9 | No | DWS Provided | No |
| No | Gutter Run Slope (%) | 6.4 | | Road Cross Slope (%) | 6.2 |

**Remove & Replace Curb Ramp With Two New Directional Ramps or Equivalent. Remove & Replace Gutter.**

**R204.3, R305, R304.5.4, STD 1115**
