# Access Compliance Report

## Public Rights-of-Way

### (Curb Ramps)

Main Street: BLUME\_DR Cross Street: FOSTER\_RD Location: SE

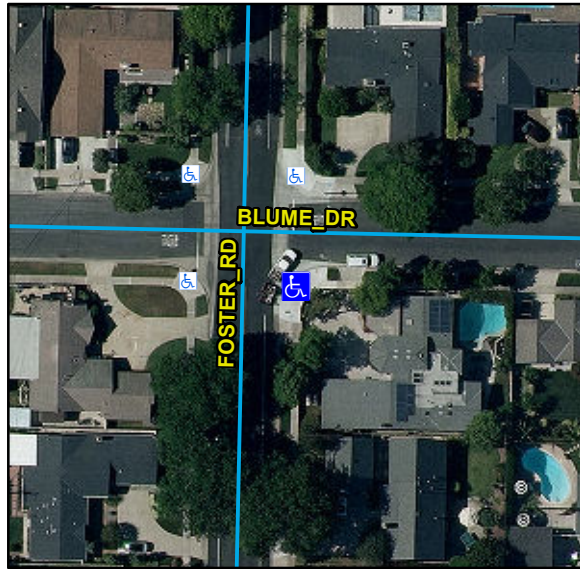
ADA ID: RPRK211216123143 Ramp Type: Type 1 - Perpendicular Diagonal Initial Pass/Fail: Pass Overall Compliance: No Severity Score: 0

| Compliance | Description | Data | Compliance | Description | Data |
|---|---|---|---|---|---|
| No | Landing Run Slope (%) | 2.3 | N/A | Flare Traversable RT | Yes |

Possible Solutions:

Remove & Replace Landing.

R304.2.2-Perp, R304.3.2-Para, STD 1115

Total Cost: \$ 531
