# Access Compliance Report Public Rights-of-Way (Curb Ramps)

Main Street: GERTRUDE\_DR Cross Street: FOSTER\_RD Location: NW

ADA ID: RPRK211216124020 Ramp Type: Type 1 - Perpendicular Diagonal Initial Pass/Fail: Pass Overall Compliance: No Severity Score: 14

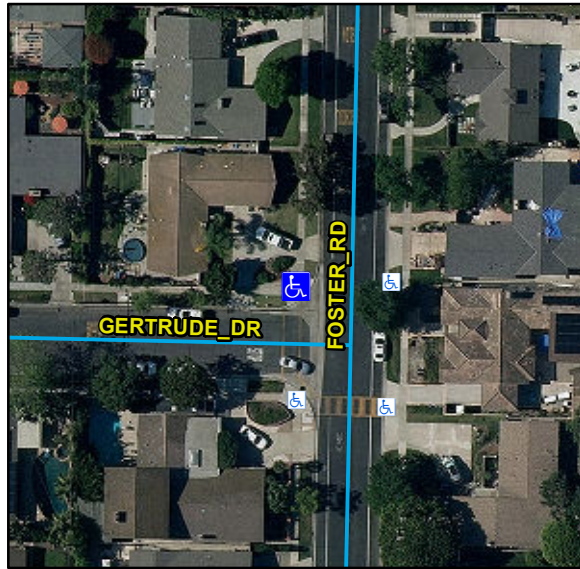
| Compliance | Description | Data | Compliance | Description | Data |
|---|---|---|---|---|---|
| No | Landing Run Slope (%) | 4.3 | N/A | Flare Traversable RT | No |
| Yes | Landing Cross Slope (%) | 0.2 | No | DWS Provided | No |

Remove & Replace Curb Ramp With Two New Directional Ramps or Equivalent.
