# Access Compliance Report Public Rights-of-Way (Curb Ramps)

Main Street: FOSTER\_RD Cross Street: ENGEL\_DR Location: SW

ADA ID: RPRK211216124344 Ramp Type: Type 1 - Perpendicular Diagonal Initial Pass/Fail: Fail Overall Compliance: No Severity Score: 15

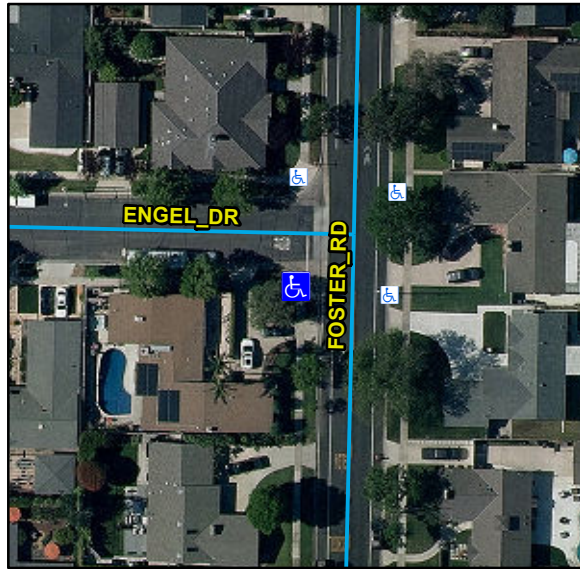
| Compliance | Description | Data | Compliance | Description | Data |
|---|---|---|---|---|---|
| No | Ramp Run Slope (%) | 8.6 | N/A | Flare Slope LT (%) | N/A |

**Remove & Replace Curb Ramp With Two New Directional Ramps or Equivalent.**

**R204.3, R304.2.2, STD 1115**
