# Access Compliance Report Public Rights-of-Way (Curb Ramps)

Main Street: ENGEL\_DR Cross Street: FOSTER\_RD Location: NW

ADA ID: RPRK211216124616 Ramp Type: Type 1 - Perpendicular Diagonal Initial Pass/Fail: Pass Overall Compliance: No Severity Score: 10

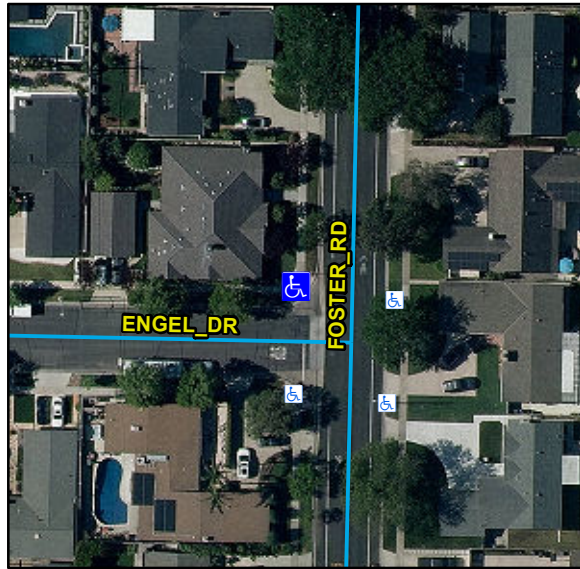
| Compliance | Description | Data | Compliance | Description | Data |
|---|---|---|---|---|---|
| Yes | Landing Cross Slope (%) | 0.5 | No | DWS Provided | No |

Remove & Replace Curb Ramp With Two New Directional Ramps or Equivalent.

R204.3, R305, STD 1115
