# Access Compliance Report Public Rights-of-Way (Curb Ramps)

Main Street: FOSTER\_RD Cross Street: BLUME\_DR Location: SW

ADA ID: RPRK211216124930 Ramp Type: Type 1 - Perpendicular Diagonal Initial Pass/Fail: Pass Overall Compliance: No Severity Score: 10

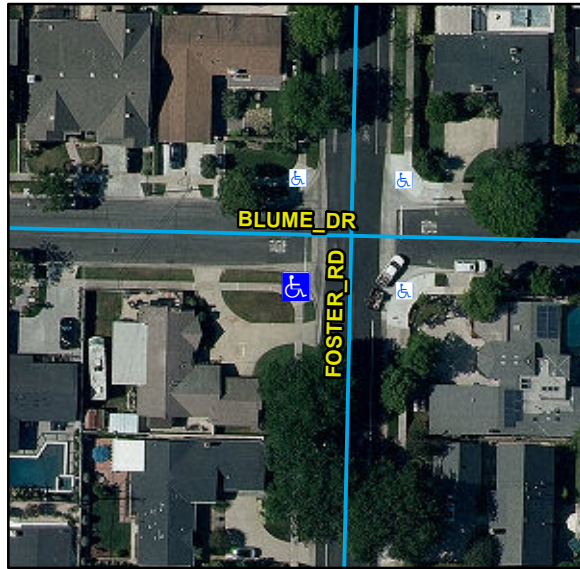
| Compliance | Description | Data | Compliance | Description | Data |
|---|---|---|---|---|---|
| No | Landing Run Slope (%) | 2.1 | N/A | Flare Traversable RT | No |
| Yes | Landing Cross Slope (%) | 0.8 | No | DWS Provided | No |
| Yes | Overall Surface Condition: Acceptable | | No | Perp Joint Present | No |

Remove & Replace Curb Ramp With Two New Directional Ramps or Equivalent.

R204.3, R304.2.2-Perp, R304.3.2-Para, R305, STD 1115
