# Access Compliance Report Public Rights-of-Way (Curb Ramps)

Main Street: BLUME\_DR Cross Street: FOSTER\_RD Location: NW

ADA ID: RPRK211216125335 Ramp Type: Type 1 - Perpendicular Diagonal Initial Pass/Fail: Pass Overall Compliance: No Severity Score: 10

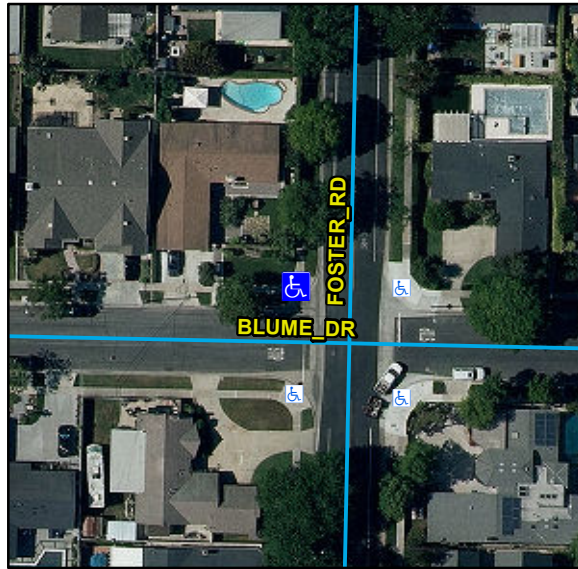
| Compliance | Description | Data | Compliance | Description | Data |
|---|---|---|---|---|---|
| No | Landing Run Slope (%) | 2.1 | N/A | Flare Traversable RT | No |
| Yes | Landing Cross Slope (%) | 0.8 | No | DWS Provided | No |

Remove & Replace Curb Ramp With Two New Directional Ramps or Equivalent.

R204.3, R304.2.2-Perp, R304.3.2-Para, R305, STD 1115

Total Cost: \$ 6160
