# Access Compliance Report Public Rights-of-Way (Curb Ramps)

Main Street: INVERNESS\_DR Cross Street: FOSTER\_RD Location: S

ADA ID: RPRK211216130140 Ramp Type: Type 1 - Perpendicular Diagonal Initial Pass/Fail: Pass Overall Compliance: No Severity Score: 10

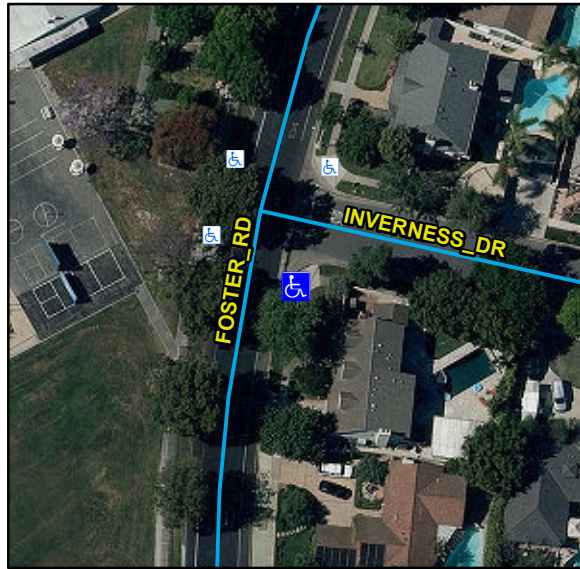
| Compliance | Description | Data | Compliance | Description | Data |
|---|---|---|---|---|---|
| No | Landing Run Slope (%) | 2.5 | N/A | Flare Traversable RT | No |
| Yes | Landing Cross Slope (%) | 0.7 | No | DWS Provided | No |
| No | Gutter Ponding | Yes | Yes | Curb Slope | 2.7 |
| No | Gutter Lip Height (in) | 0.25 | | Road Run Slope (%) | 0.2 |

**Remove & Replace Curb Ramp With Two New Directional Ramps or Equivalent. Grind Gutter Lip.**

**R204.3, R304.2.2-Perp, R304.3.2-Para, R305, R302.7, R302.7.2, STD 1115**
