# Access Compliance Report Public Rights-of-Way (Curb Ramps)

Main Street: FOSTER\_RD Cross Street: INVERNESS\_DR Location: E

ADA ID: RPRK211216130451 Ramp Type: Type 1 - Perpendicular Diagonal Initial Pass/Fail: Pass Overall Compliance: No Severity Score: 10

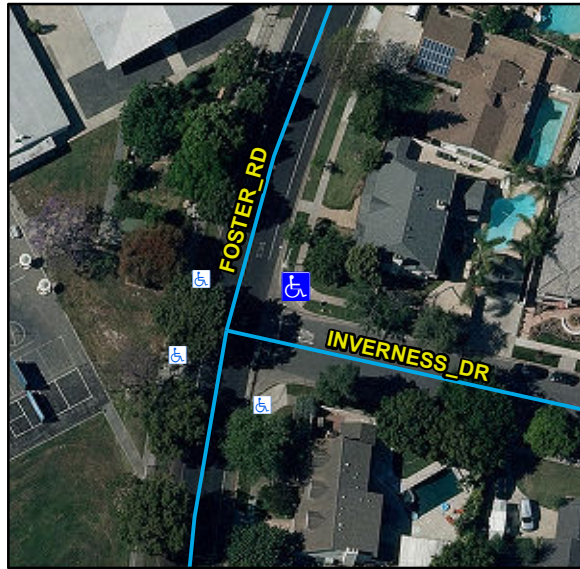
| Compliance | Description | Data | Compliance | Description | Data |
|---|---|---|---|---|---|
| No | Landing Run Slope (%) | 2.5 | N/A | Flare Traversable RT | No |
| Yes | Landing Cross Slope (%) | 0.3 | No | DWS Provided | No |

Remove & Replace Curb Ramp With Two New Directional Ramps or Equivalent.

R304.2.2-Perp, R304.3.2-Para, R305, STD 1115
