# Access Compliance Report Public Rights-of-Way (Curb Ramps)

Main Street: ACECA\_DR Cross Street: FOSTER\_RD Location: S

ADA ID: RPRK211216130816 Ramp Type: Type 1 - Perpendicular Diagonal Initial Pass/Fail: Pass Overall Compliance: No Severity Score: 14

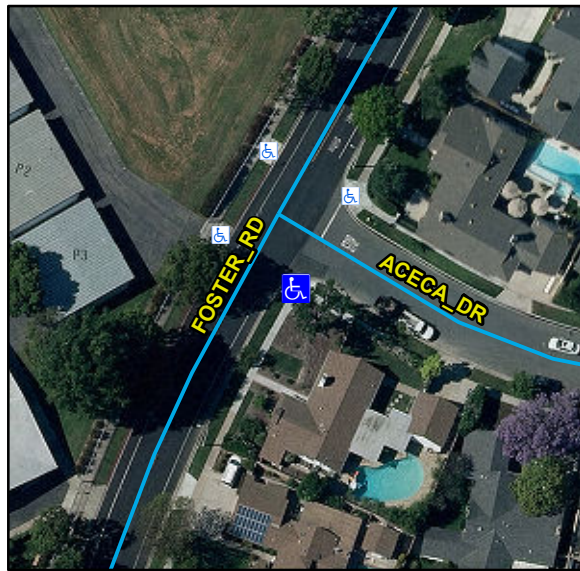
| Compliance | Description | Data | Compliance | Description | Data |
|---|---|---|---|---|---|
| No | Landing Run Slope (%) | 5.6 | N/A | Flare Traversable RT | Yes |
| No | Gutter Run Slope (%) | 5.1 | | Road Cross Slope (%) | 6.4 |

Remove & Replace Landing. Remove & Replace Gutter.
