# Access Compliance Report Public Rights-of-Way (Curb Ramps)

Main Street: FOSTER\_RD Cross Street: ACECA\_DR Location: E

ADA ID: RPRK211216131230 Ramp Type: Type 1 - Perpendicular Diagonal Initial Pass/Fail: Pass Overall Compliance: No Severity Score: 2

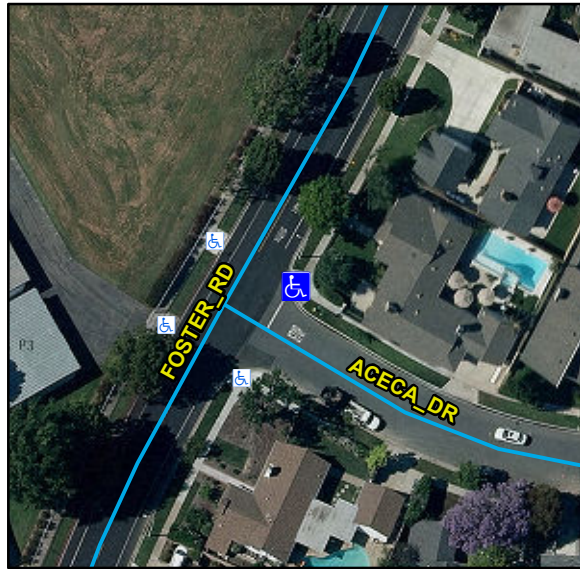
Gutter Ponding Observed.

| Compliance | Description | Data | Compliance | Description | Data |
|---|---|---|---|---|---|
| No | Gutter Ponding | Yes | Yes | Curb Slope | 2.2 |

R302.7, STD 1115

Total Cost: \$ 252
