# Access Compliance Report Public Rights-of-Way (Curb Ramps)

Main Street: SILVER\_FOX\_RD Cross Street: INVERNESS\_DR Location: SW

ADA ID: RPRK211216131814 Ramp Type: Type 1 - Perpendicular Diagonal Initial Pass/Fail: Fail Overall Compliance: No Severity Score: 2

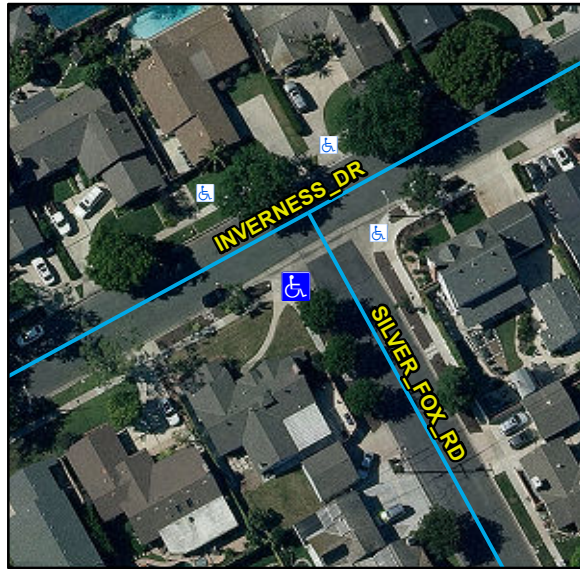
| Compliance | Description | Data | Compliance | Description | Data |
|---|---|---|---|---|---|
| No | Ramp Cross Slope (%) | 2.4 | N/A | Flare Traversable LT | N/A |

Remove & Replace Curb Ramp With Two New Directional Ramps or Equivalent.

R204.3, R304.5.3, STD 1115
