# Access Compliance Report Public Rights-of-Way (Curb Ramps)

Main Street: NORGROVE\_LN Cross Street: ACECA\_DR Location: NE

ADA ID: RPRK211216132933 Ramp Type: Type 1 - Perpendicular Diagonal Initial Pass/Fail: Pass Overall Compliance: No Severity Score: 16

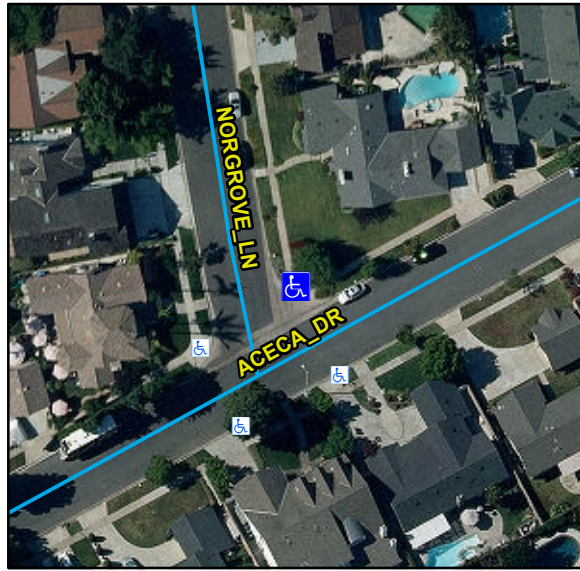
| Compliance | Description | Data | Compliance | Description | Data |
|---|---|---|---|---|---|
| No | Landing Run Slope (%) | 2.2 | N/A | Flare Traversable RT | No |
| Yes | Landing Cross Slope (%) | 0.1 | No | DWS Provided | No |

Remove & Replace Curb Ramp With Two New Directional Ramps or Equivalent.
