# Access Compliance Report Public Rights-of-Way (Curb Ramps)

Main Street: NEWBURY\_RD Cross Street: ACECA\_DR Location: SW

ADA ID: RPRK211216134235 Ramp Type: Type 1 - Perpendicular Diagonal Initial Pass/Fail: Fail Overall Compliance: No Severity Score: 16

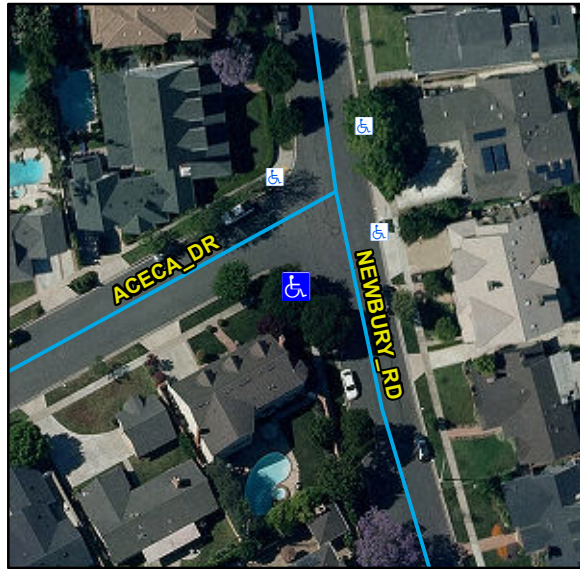
| Compliance | Description | Data | Compliance | Description | Data |
|---|---|---|---|---|---|
| No | Ramp Run Slope (%) | 9.1 | N/A | Flare Slope LT (%) | N/A |

Remove & Replace Curb Ramp With Two New Directional Ramps or Equivalent.

R204.3, R304.2.2, STD 1115
