# Access Compliance Report Public Rights-of-Way (Curb Ramps)

Main Street: INVERNESS\_DR Cross Street: NEWBURY\_RD Location: NW

ADA ID: RPRK211216134436 Ramp Type: Type 1 - Perpendicular Diagonal Initial Pass/Fail: Pass Overall Compliance: No Severity Score: 0

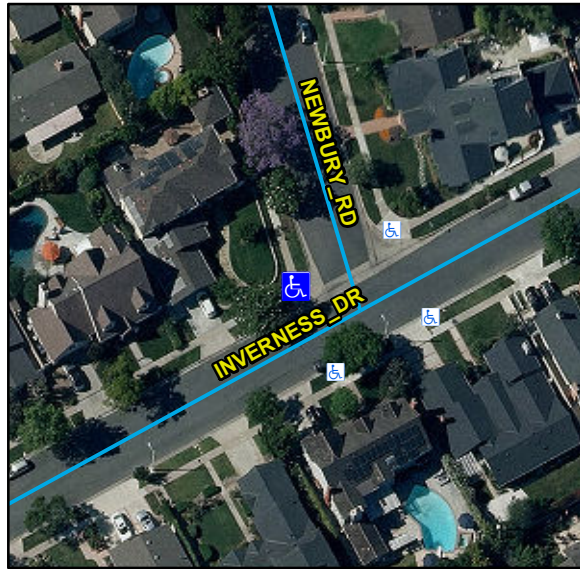
| Compliance | Description | Data | Compliance | Description | Data |
|---|---|---|---|---|---|
| No | Landing Run Slope (%) | 2.1 | N/A | Flare Traversable RT | No |

Remove & Replace Landing.

R304.2.2-Perp, R304.3.2-Para, STD 1115

Total Cost: \$ 531
